4/08/2020

# More workers falling through roofs in NSW

## Incident Information Release

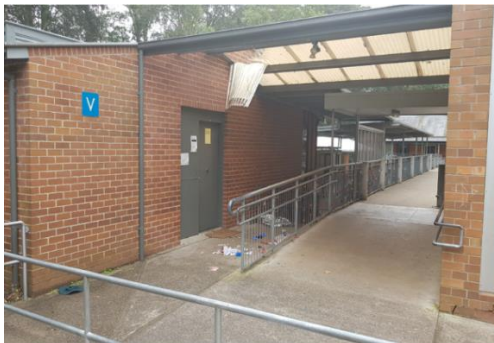
A 52-year-old subcontractor has fallen 3.5 metres onto concrete pavement at a school in Wahroonga. The subcontractor was cleaning the roof gutters when he stepped onto polycarbonate roof sheeting which gave way causing him to fall through. He sustained severe head injuries in the fall and passed away in hospital.

*The site where the incident occurred at Wahroonga*

Not all areas on a roof are safe to walk on. Even roof sheeting that claims to be okay to walk on is reliant on correct installation and can become brittle over time. Don't walk on skylights, or plastic and asbestos roof sheeting, unless assessed as structurally sound by a competent person.

If you must access the roof, check its condition, the roofing materials, fixings and safety mesh to determine the safest path.

If sheeting appears brittle, you must manage the risks of falling through the roof.

- install guardrails around non-trafficable areas, or use a work positioning system
- cover non-trafficable sheeting securely and place warning signs nearby
- work from temporary work platforms (crawling boards) or roof ladders, where appropriate
- install safety mesh
- use an adjustable fall-arrest system, such as a harness, with proper anchor points, and train workers in how to use them
- prepare a site specific safe work method statement (SWMS) for all high risk construction work

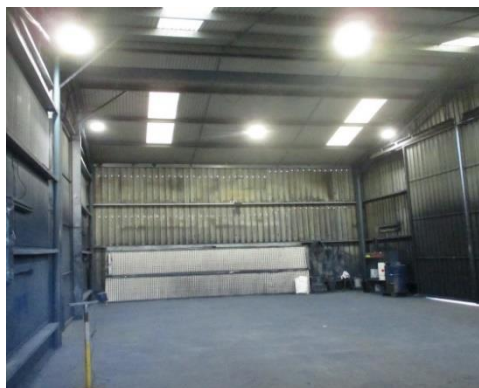
Last month a 21-year-old apprentice carpenter fell through perspex roof sheeting at a manufacturing plant in central western NSW. He landed on the concrete floor 7 metres below, fracturing his wrist, ribs and pelvis.

*The shed where the carpenter fell, noting the perspex roof sheeting*
