<p>ISSUE:</p> <p>AS-BUILT</p> <p>27/09/2021</p> <p>AnchorSafe Projects</p>	<p>BY: DZ</p>	<p>APPROVED: DG</p>		<p>CLIENT:</p> <p>EXAMPLE AS-BUILT</p>	<p>TITLE:</p> <p>EXAMPLE AS-BUILT SITE INSPECTION & AUDIT OF EXISTING HEIGHT SAFETY SYSTEM SECTION 1</p>	<p>Quote No:</p> <p>-</p>
	<p>DRAWN: ANCHORSAFE</p>	<p>CHECKED:</p>		<p>SCALE:</p>		<p>Job No:</p> <p>-</p>
						<p>Quote No:</p> <p>-</p>

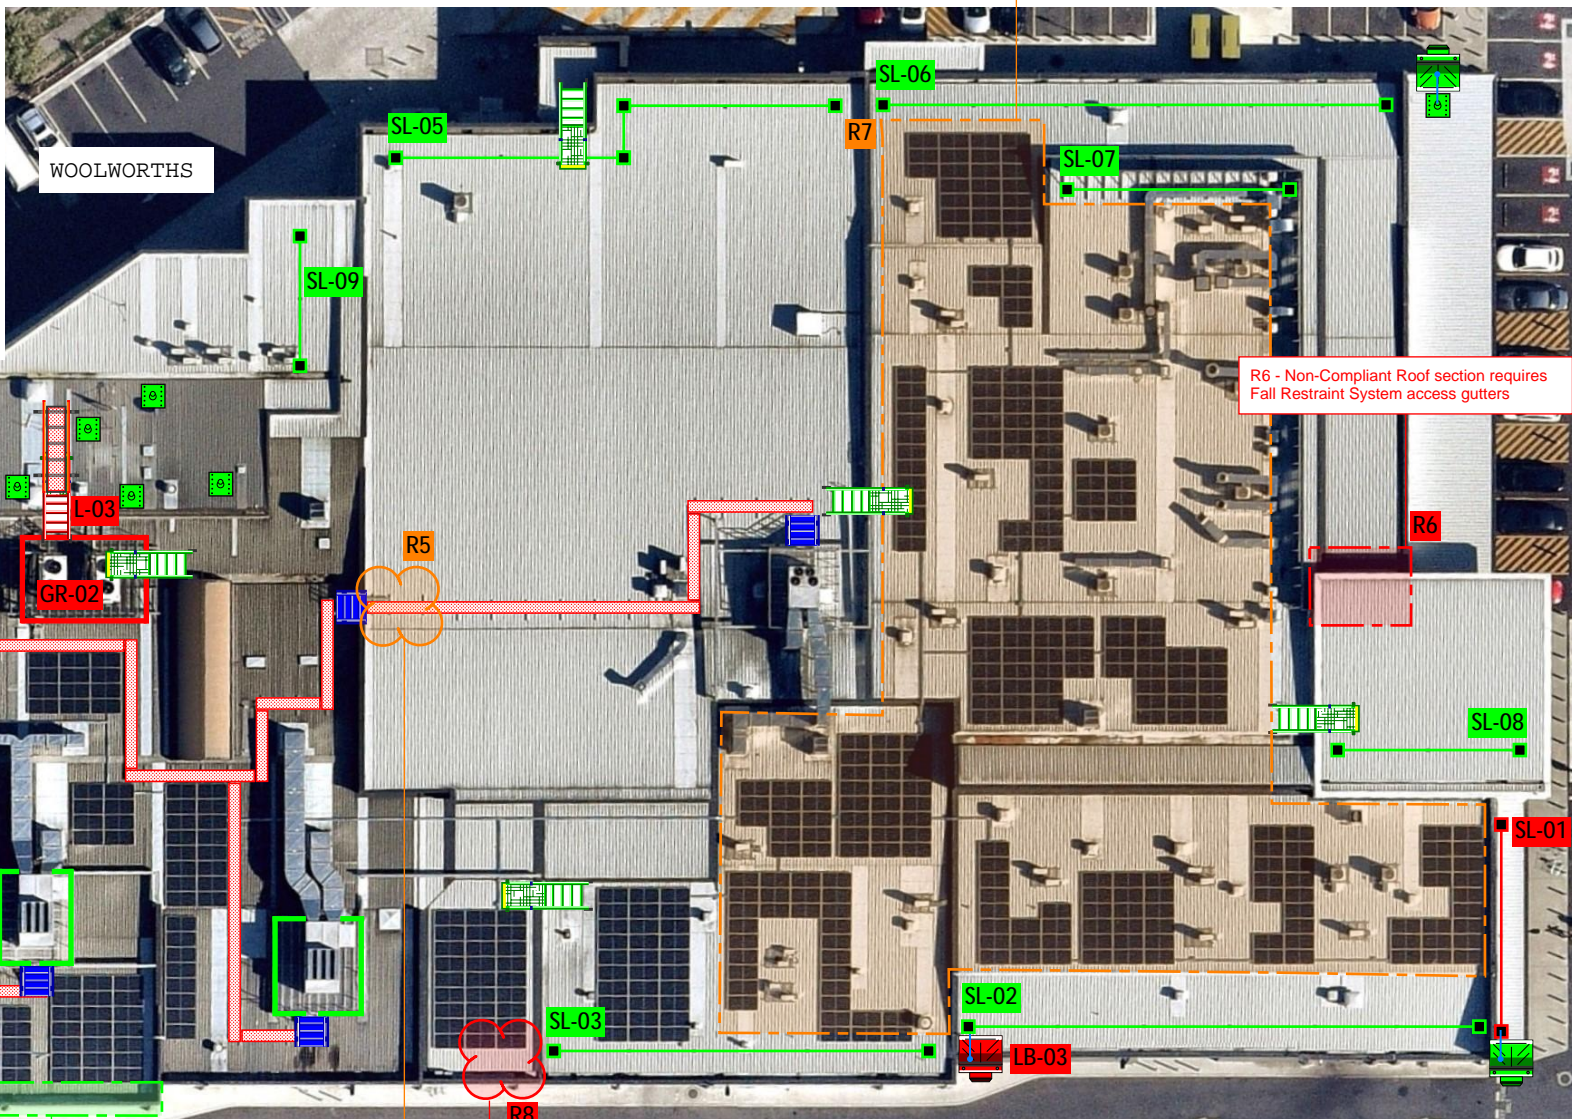
R7 - Walkway required to provide ease of access to all AC Units & Solar Panels requiring maintenance

R1 - Non-Compliant Roof Section requires Fall Restraint Access System

R6 - Non-Compliant Roof section requires Fall Restraint System access gutters

R2 - Non-Compliant Roof section requires additional Anchor Points to eliminate fall hazard

R3 - Parapet Crossover System required to provide Compliant Access, 1500x600mm

R4 - Parapet Crossover System required to provide Compliant Access, 1000x500mm

Parapet Wall over 900mm, no fall restraint System required here

R5 - Guardrail to be at 2m in length at both sides of entry required for Compliant Access

R8 - Additional Anchor Point required for compliant access to Gutter
