Practical solutions for livestock safety

Project: Wangaratta Livestock Exchange – Browns Wangaratta on behalf of Wangaratta City Council

Solution Design

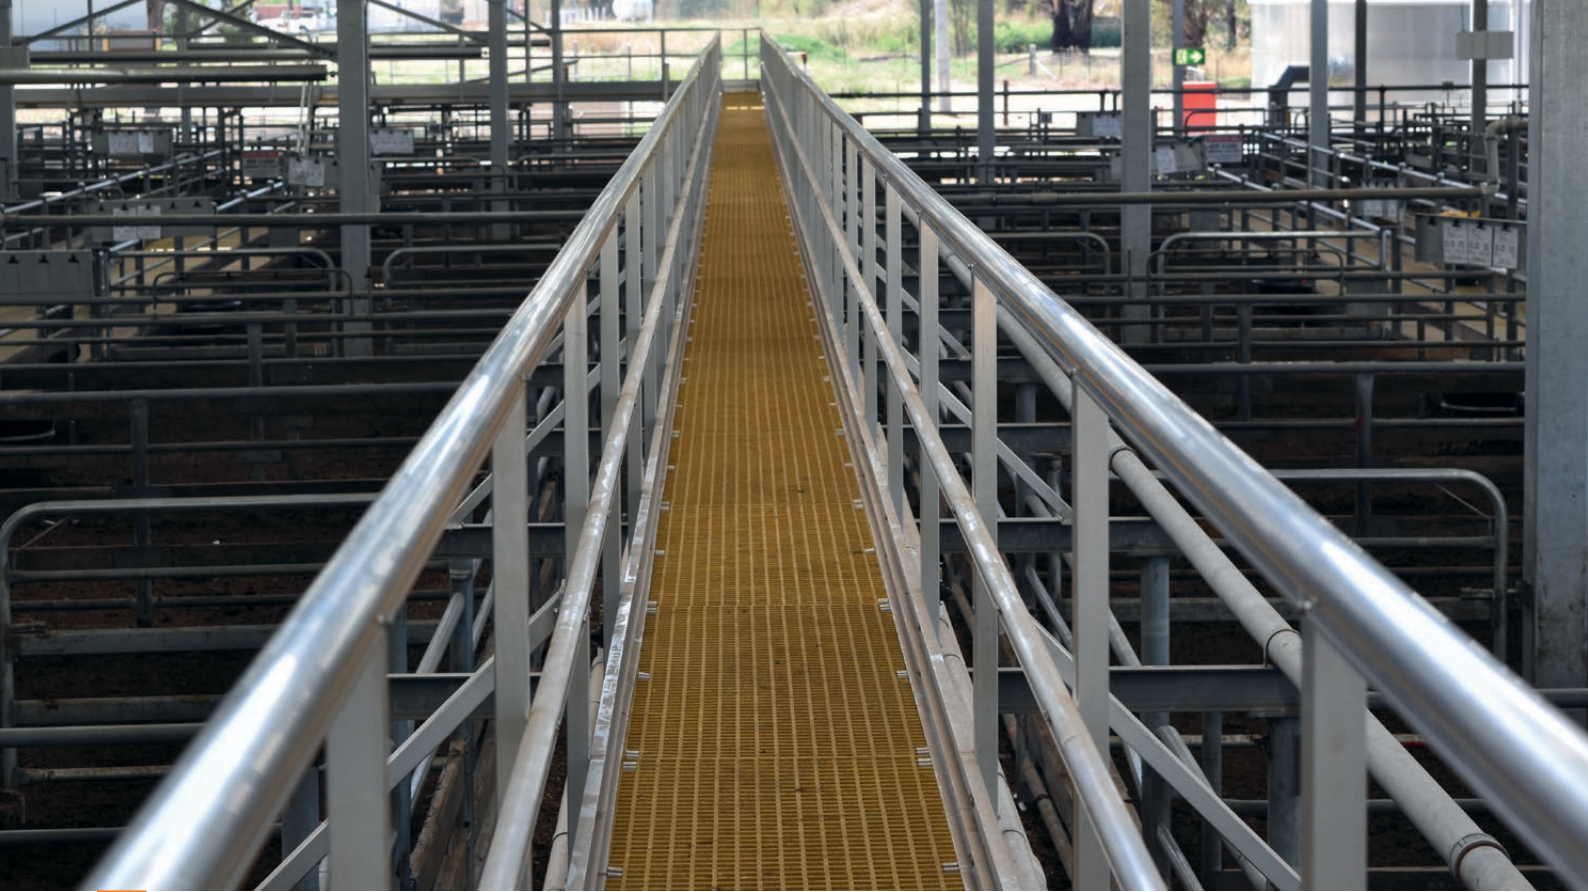
Elevated Fibre Reinforced Polyester walkway with double sided guardrail, for auctioneers to walk along at the Wangaratta Livestock exchange.

We proposed a three-stage solution so the exchange could continue operating without interruption while the upgrade took place. Our new high span walkway was constructed along the same alignment as the existing walkway, attaching to the existing overhead bearers for support.

- 545m of KOMBI elevated walkway system, including extended posts and double kick rail
- 4 x FC7195 – ALTO Stairways 2300mm High x 600mm wide with 900mm landing including guardrail both sides

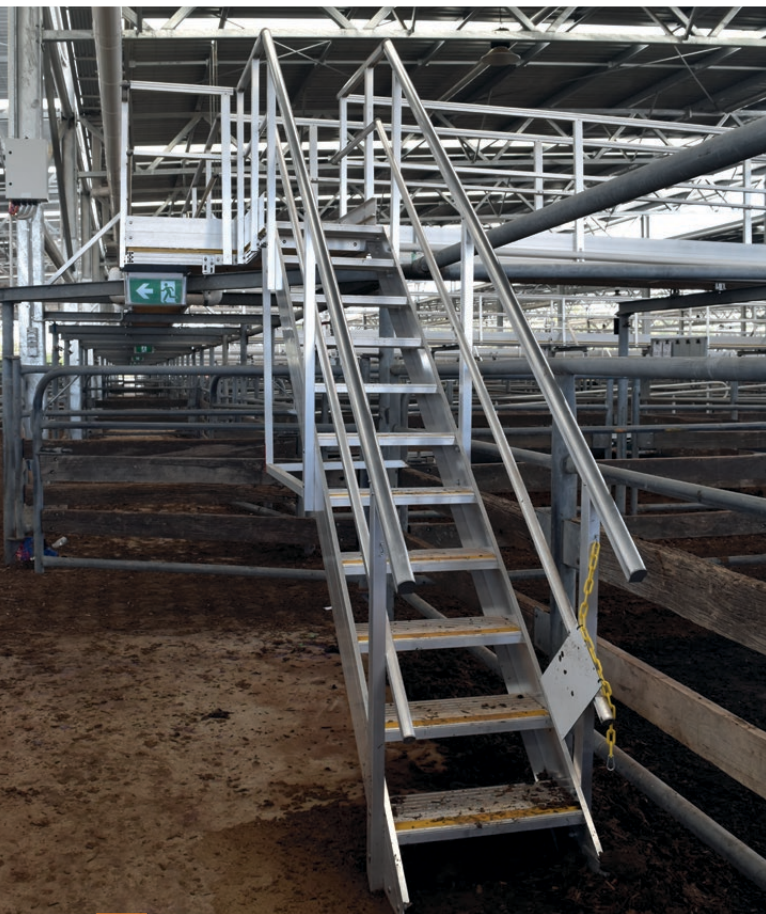
Aluminium Stairway for access up onto the elevated walkway.
